RT-Bolt

Assembly and Monitoring of High Temperature Heat Exchanger Joints

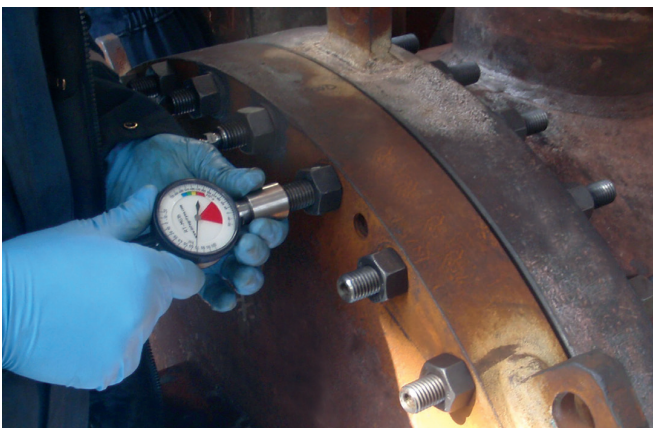
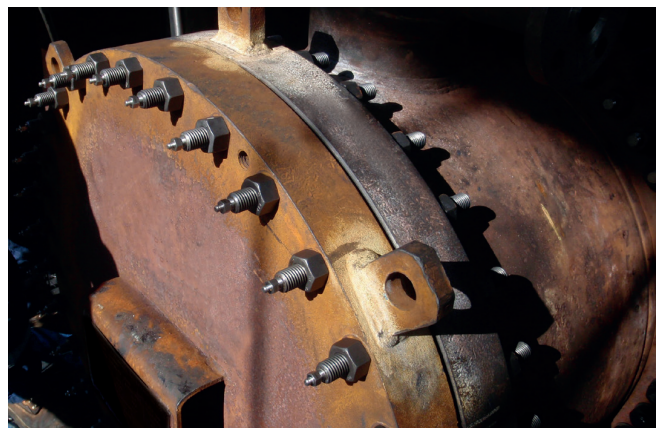
RT-Bolt load measurement underway during assembly of an exchanger channel cover with 3/4" diameter bolts

RT-Bolts were machined into a set of 3/4 inch diameter A193-B16 bolts, in order to facilitate accurate assembly of the joint to 90% of yield and allow ongoing monitoring of the residual bolt load using the ceramic high temperature RT-Bolt gauges.
