RT-Bolt

Coke Drum Bottom Deheading Valve Joint Assembly and Monitoring

Integrity Assurance for Offshore Platform Compact Flange Conversion

Assembly and Monitoring of High Temperature Heat Exchanger Joints

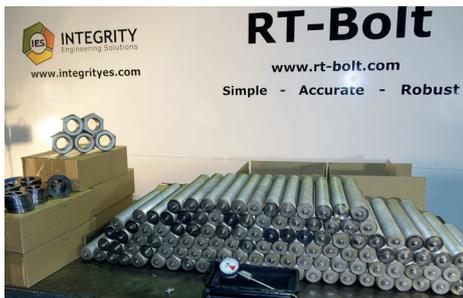
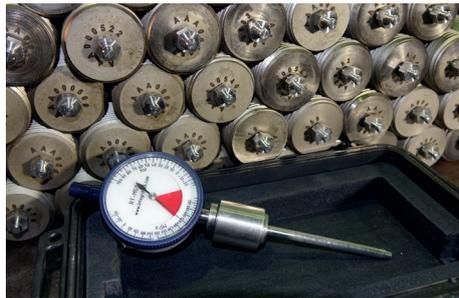
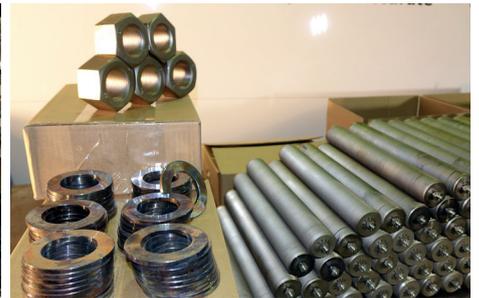
120 RT-Bolts, with hardened washers and machined nuts, all specially coated, ready for installation on site

RT-Bolts have been employed across several coker units to ensure accurate joint assembly, to monitor the bolt load during operation, to set the required torque for online tightening and to continue to monitor the bolt load after re-tightening. To overcome common problems with bolts galling, the RT-Bolts for this application are supplied with a special coating, hardened machined and coated washers, and machined and coated nuts.

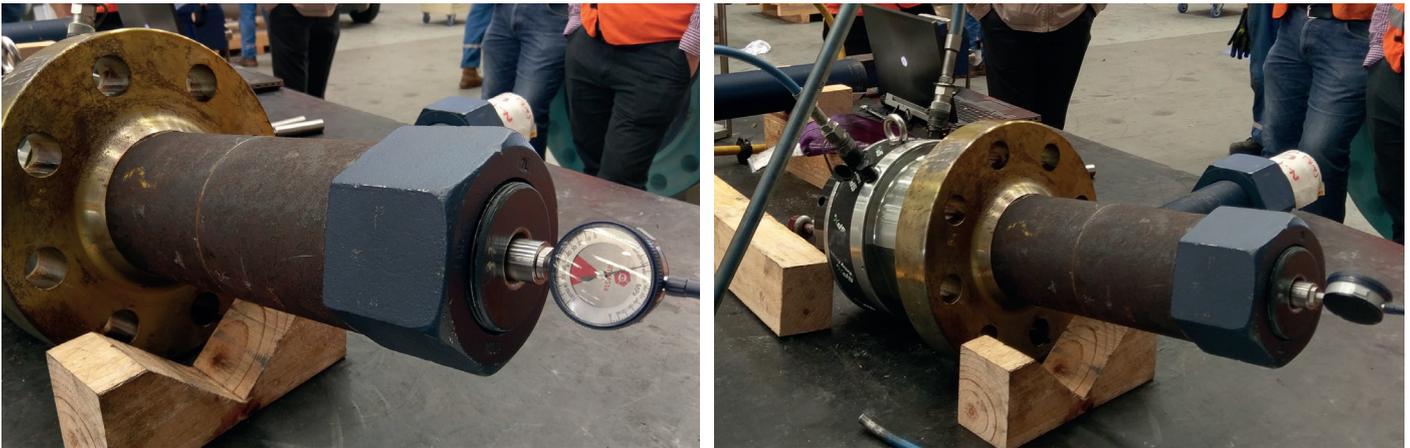
RT-Bolt acceptance testing underway, witnessed by client representatives

RT-Bolts were machined into a set of 3-1/4 inch diameter x 30 inch long A320-L7 bolts, in order to facilitate accurate assembly of the joint, should the kamprofile gasket option be employed.

The RT-Bolts passed the end-user inspection, verification and testing with flying colours and are now in storage, for use should they be required. The accuracy and repeatability of the bolts was confirmed by the multinational end-user client's engineers via comprehensive site acceptance testing.

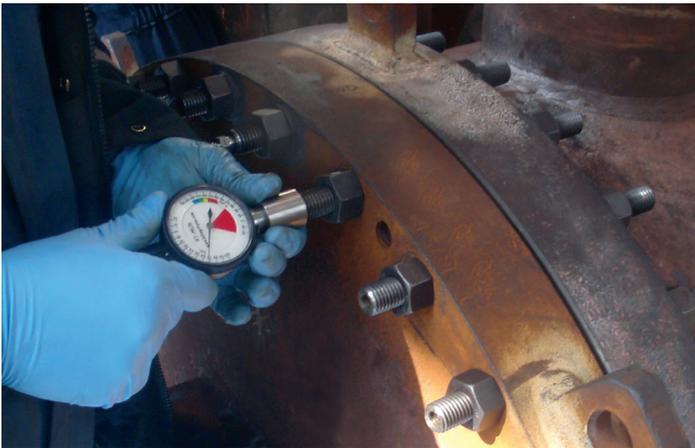
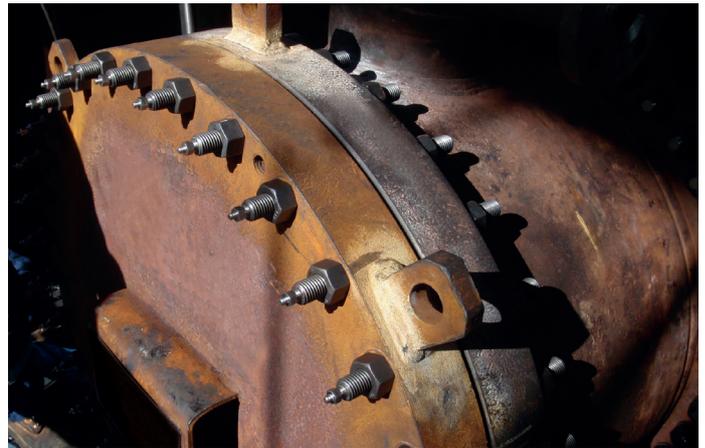
RT-Bolt load measurement underway during assembly of an exchanger channel cover with $\frac{3}{4}$ " diameter bolts

RT-Bolts were machined into a set of $\frac{3}{4}$ inch diameter A193-B16 bolts, in order to facilitate accurate assembly of the joint to 90% of yield and allow ongoing monitoring of the residual bolt load using the ceramic high temperature RT-Bolt gauges.

The RT-Bolts worked well for assembly and the joints were brought online with no leakage issues. Online measurement of the bolt load indicated that some bolt relaxation or bolt yielding may have occurred, which will be investigated further once the joints are taken out of service.
